## GEPS - Collaboration between EXLTERRA and Aa Saint-Omer Golf Club

### Comparative Empirical Observation Study - N+1 and N+2 Observation Report

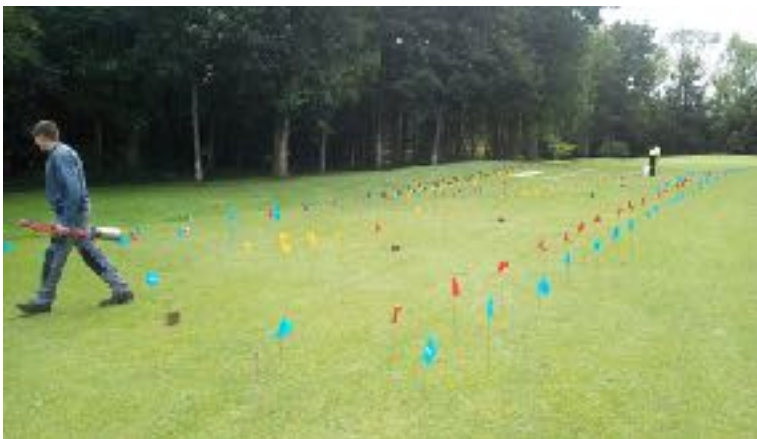
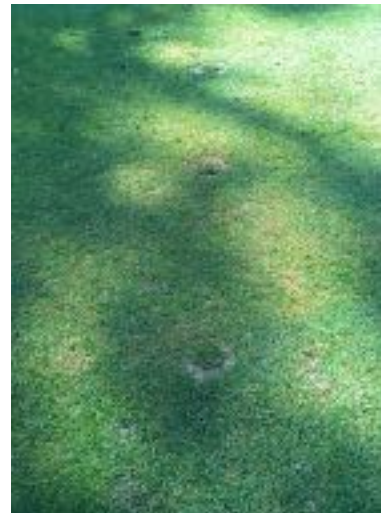
*September 2020*

*GEPS installation: preparation and condition of the area for reopening to play*

At the time of your visit, the installation site was completed in 4 days for the 2 zones thanks to your professional team, which was concerned with respecting our quality constraints. The installation was done locally, without the need to be connected to a network. The stigmata were almost invisible to the players and we were able to reopen the game as soon as your drill rig left the affected areas. This is a very positive point of your system.

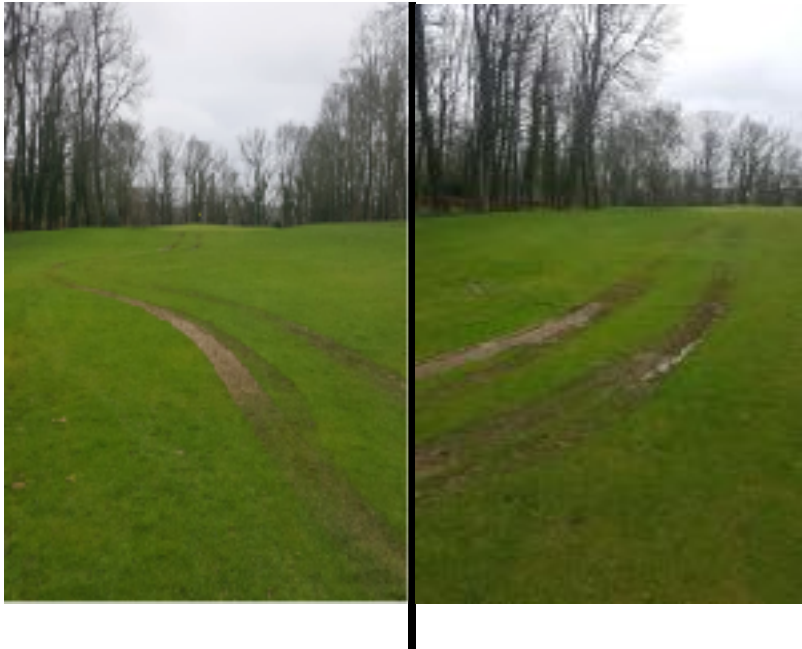
*March 2020*

*Before installation of  
GEPS*

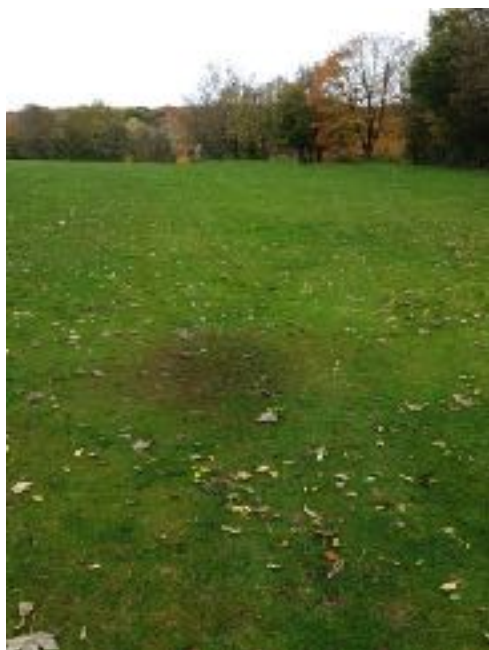
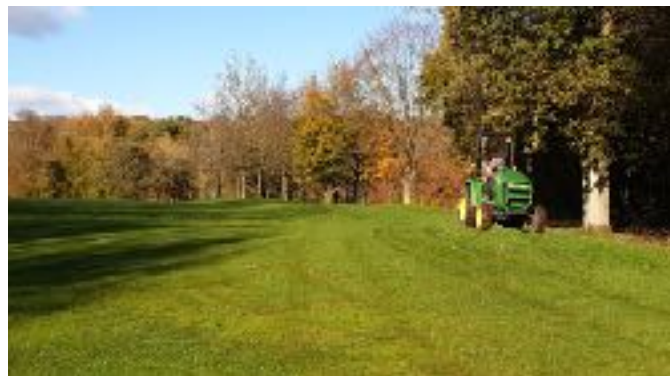
*4 November 2020*

*8 weeks after installation*

*81 mm of rain in September*

*217 mm of rain in October*

- On our fairway, the system acclimatized very quickly since it was already quite effective from a water infiltration point of view after 4 weeks and we were able for the first time to mow the entire fairway all year long.
- We note a stabilization and a greater firmness of the ground in wet periods in this zone in direct comparison with the beginning of the same fairway which is not equipped with GEPS.

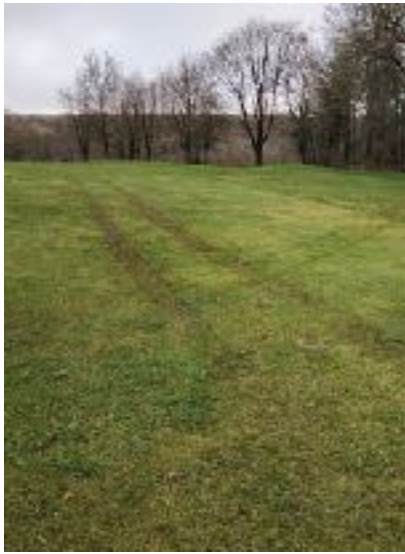
*28 January 2021  
After 209 mm of  
rain in 3 weeks*

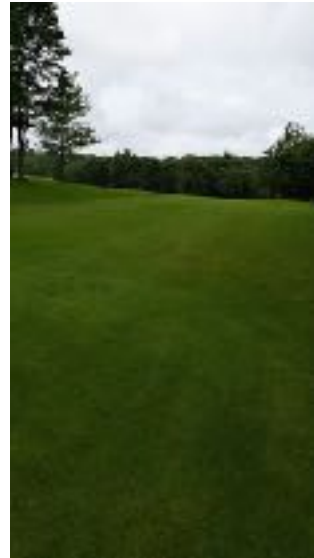
*28 June 2021  
After 100mm of rain in  
3 weeks*

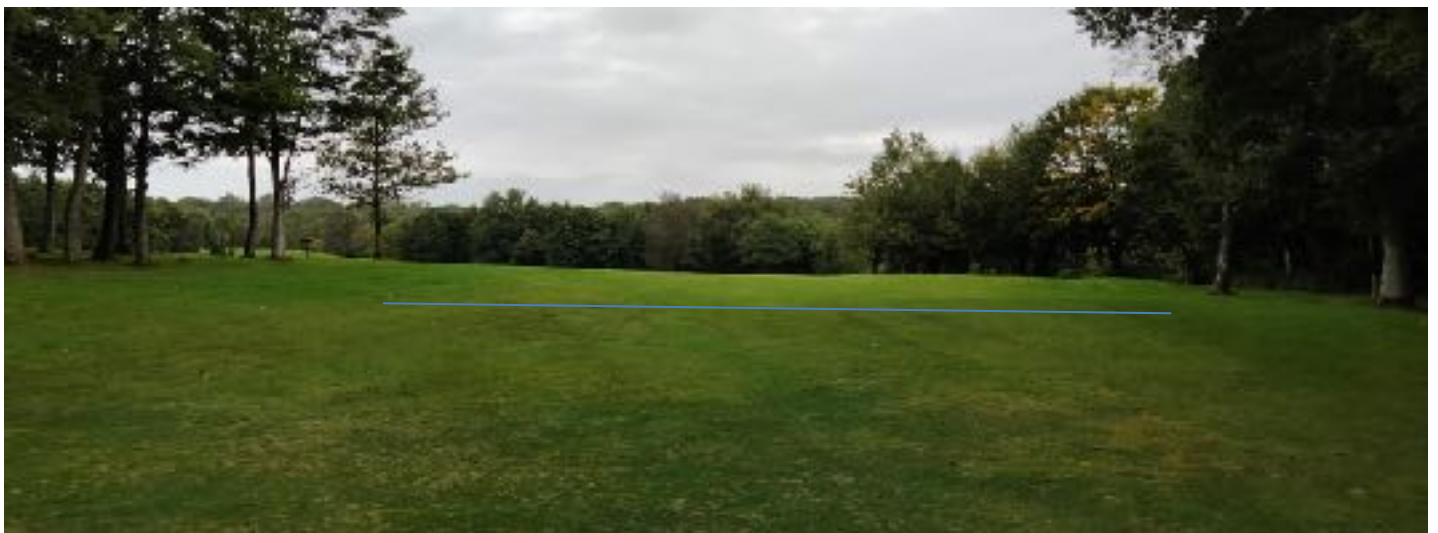
*3 October 2021*

*After 70 mm of rain during the week: the blue line shows the limit of GEPS installation.  
No trace 2 days later*

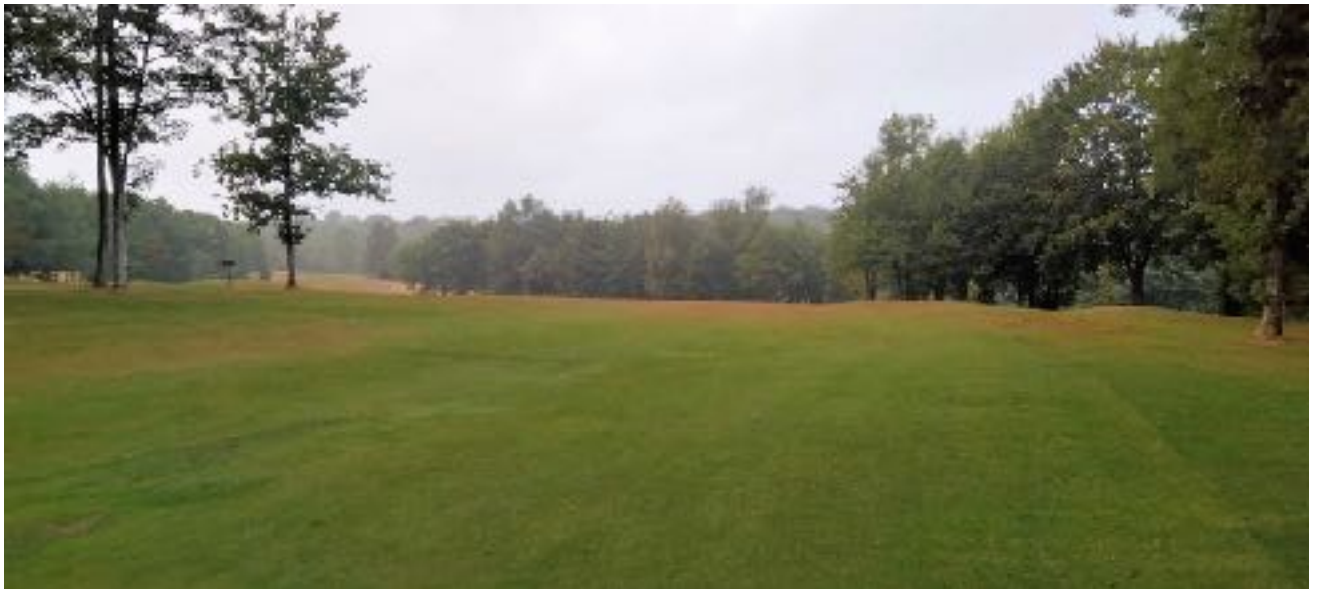
*19 July 2022 – Area of Fairway n°5 equipped with GEPS*

- While the two photos were not taken on the same day or with the same sunlight, the difference in plant cover is striking. The GEPS system allowed for some moisture to be maintained, which is essential for turfgrass activity. Only in this area was the ground cover not under water stress.
- We do not have any automatic watering systems on the fairways. This green and rather dense aspect is therefore a result of the installation of GEPS in this area.
- The mowing time for the fairways is usually 15 hours twice a week. The drought has changed our maintenance plan as we have been mowing only 2-3 hours per week in the areas near the sprinklers to keep the course clean and limit summer grass growth.

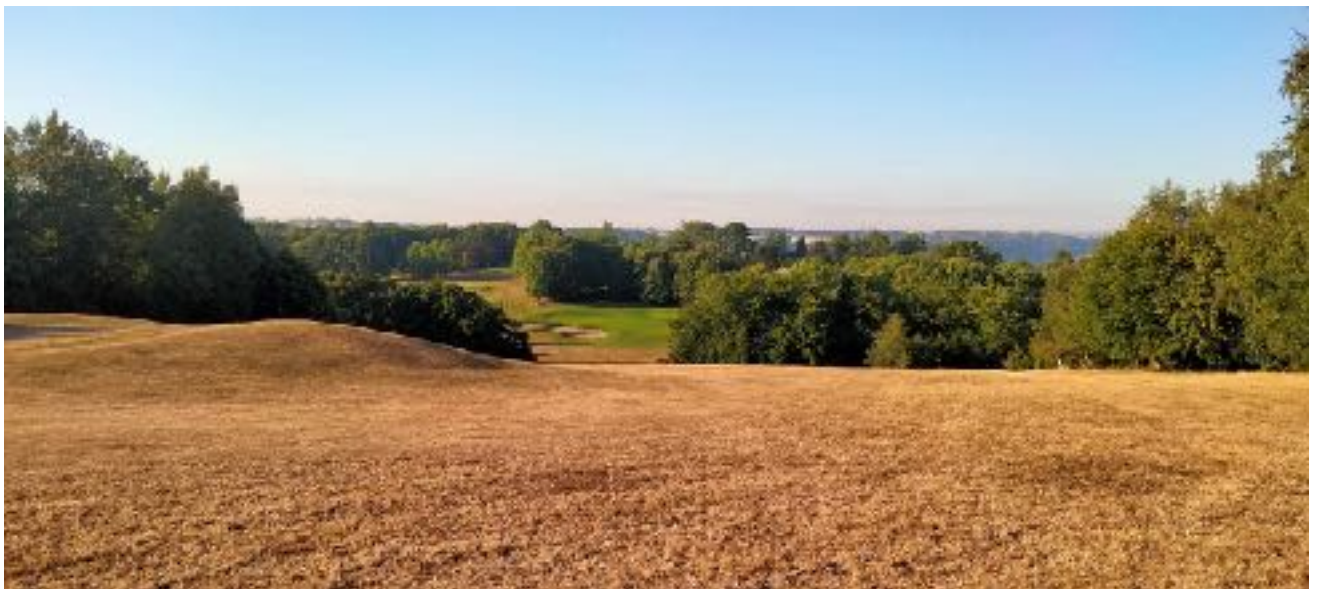
*11 July 2022 – Fairway n°13: Area not equipped with GEPS*
